# **INDOOR AIR QUALITY ASSESSMENT**

**Furnace Brook Middle School  
500 Furnace Street  
Marshfield, Massachusetts**

Prepared by:  
Massachusetts Department of Public Health  
Bureau of Environmental Health  
Indoor Air Quality Program  
November 2018

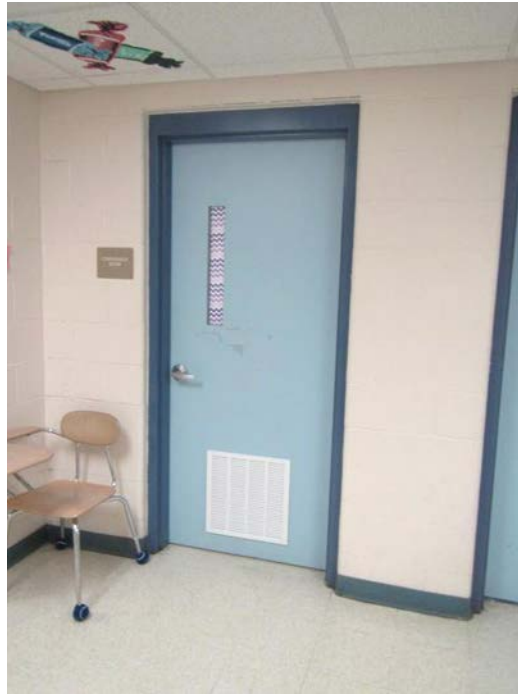
**Picture 1**

Classroom 1A has no means of mechanical supply ventilation but relies on openable windows for introduction of outside air. Classroom 1A does contain a mechanical exhaust vent; in addition, a passive door grill was recently installed to draw air from the hallway to facilitate air exchange (Picture 1).

**Passive grill in door of Classroom 1A**

3. Discontinue use of air deodorizers in restrooms.
4. Consider installing a mechanical source of fresh air for Classroom 1A.
5. Use openable windows to supplement fresh air during temperate weather. Ensure all windows are tightly closed at the end of the day.

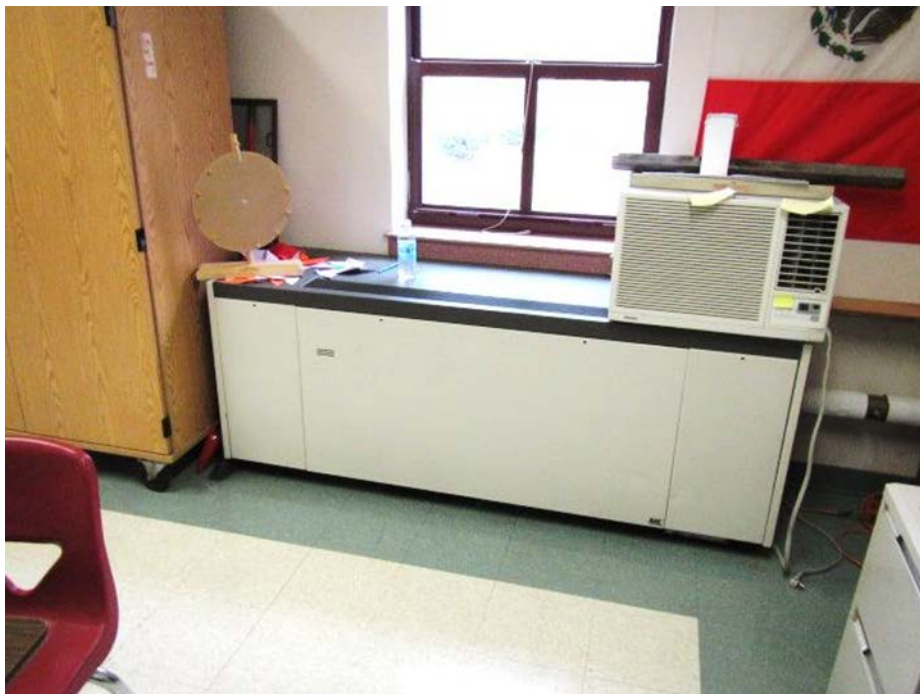
**Picture 2**

Mechanical ventilation for classrooms 1 and 3 is provided by unit ventilators “univents” located near classroom windows (Picture 2). Univents draw air from the outdoors through a fresh air intake located on the exterior wall of the building and return air through an air intake located at the base of the unit. Fresh and return air are mixed, filtered, heated or cooled and provided to rooms through an air diffuser located in the top of the unit ([Figure 1](#)). The univent in classroom 3

was deactivated; therefore no mechanical source of fresh air was being introduced at the time of assessment.

**Typical classroom univent**

6. Operate HVAC equipment (univents/exhausts) *continuously* during occupied periods. Remove all obstructions from the front and top of the univents.
7. Reduce the use of cleaning products, sanitizers and other products containing VOCs. Use only school-issued products, ensure they are properly labeled, and keep material safety sheets on file for each product at the school.

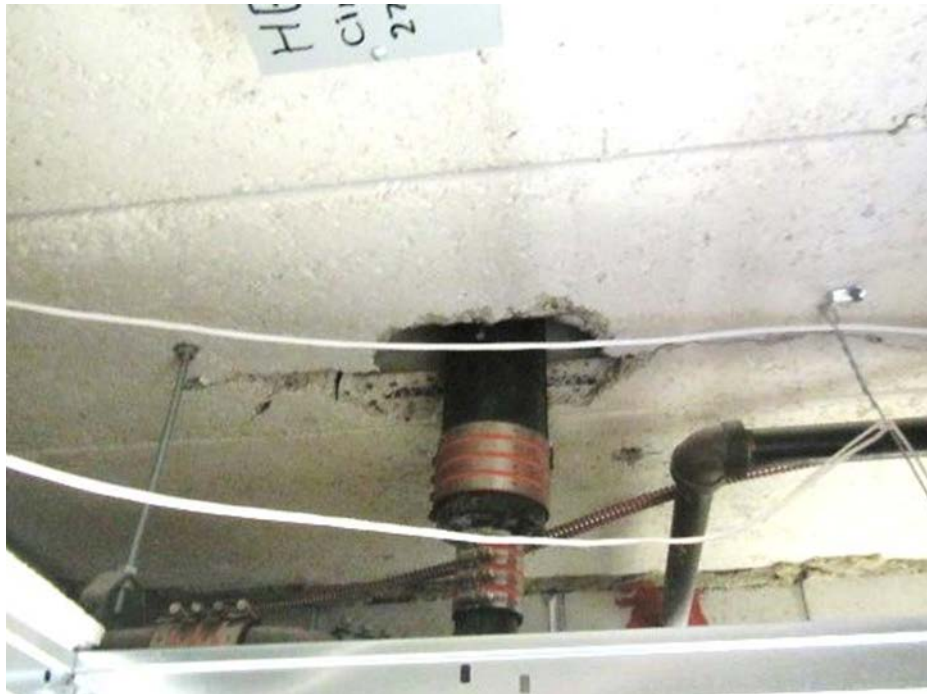
**Picture 3**

Exposure to low levels of total volatile organic compounds (TVOCs) may produce eye, nose, throat, and/or respiratory irritation in some sensitive individuals. To determine if VOCs were present, BEH/IAQ staff took measurements with a photo-ionization detector (PID) and examined rooms for products containing VOCs. As mentioned, the assessment was prompted by odor complaints, described by occupants as a “chemical, industrial-type odor” No specific source for the odors was identified in the room. BEH/IAQ staff observed an open utility hole in the concrete ceiling above the ceiling tile system (Picture 3). Measurable levels of TVOCs (16 ppm) were detected when the PID probe was inserted into this hole. The source of odors is likely roofing compounds/materials. In addition, several other open holes were observed in the concrete ceiling (Picture 4).

**Open utility hole in concrete ceiling in Classroom 1A**

1. Seal all open utility holes in Classroom 1A, men's faculty restroom and Auditorium.
2. Ensure local exhaust vents are operable in restrooms and make repairs as necessary.

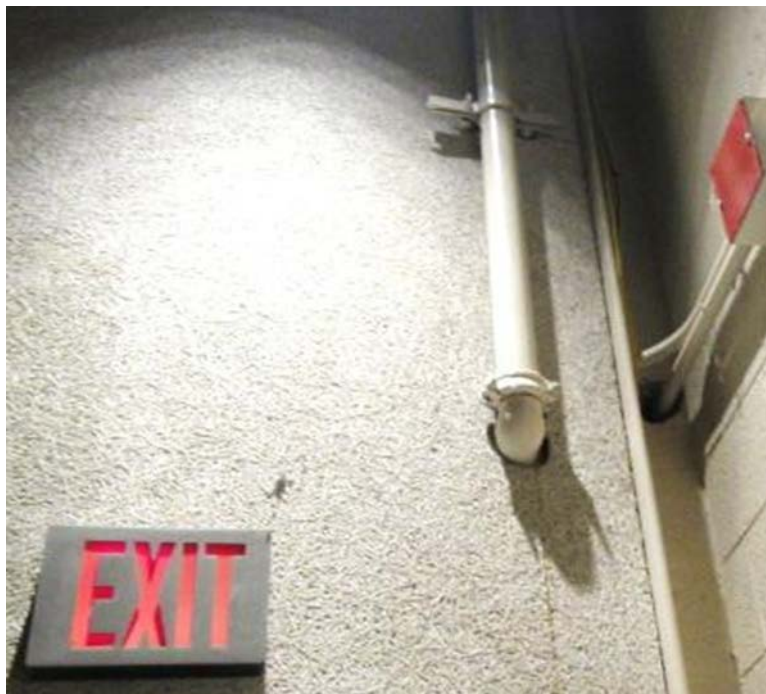
**Picture 6**

Odors were also reported in the faculty men’s room and measureable levels of TVOCs were traced to an air deodorizer (Picture 5). The ceiling in this room should also be examined for similar utility holes as found in Classroom 1A. Open utility holes with noticeable drafts were observed in the Auditorium (Picture 6).

**Open utility holes in Auditorium**
